Pentium® Pro Processor Specification Update

Release Date: November 1998

Order Number: 242689-033

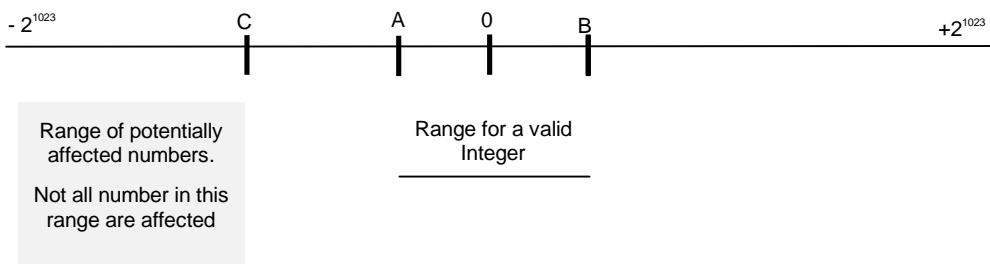
- The PE (precision error) bit the Floating Point status word is *not set*.
- Vector to the user numeric exception handler.

IMPLICATION: Erroneous operation results when the operand is so large that it will not fit into the target data size. The operands affected by this erratum are significantly outside (by a factor of 3X) the range that can be, correctly, converted to an integer value. The figure below and corresponding table identifies the normal range of integer numbers (between A and B) and the starting point of the operands affected by this erratum. Discrete failing operands will be present in the range between point C and the maximum negative number that can be represented by the processor (-2^{1023} in double precision format). Note 2 below gives a qualitative description of the nature of the discrete failing values. Software that does not rely on the Invalid Operation exception flag being set and signaled by either an exception OR by software polling is not impacted by this erratum.

16-bit Operation	A	B	C
	-32,768.0	+32,767.0	< -98304.0
32-bit Operation	A	B	C
	-2,147,483,648.0	+2,147,483,647.0	< -6,442,450,944.0

WORKAROUND: Any of two software workarounds will avoid occurrence of this erratum:
